# PILE RESTORATION OF THE LAKE PONTCHARTRAIN CAUSEWAY WORLD'S LONGEST BRIDGE

Bruce Trader  
MADCON Corporation  
3275 Bethany Lane  
Ellicott City, MD 21042  
U.S.A.

## ABSTRACT

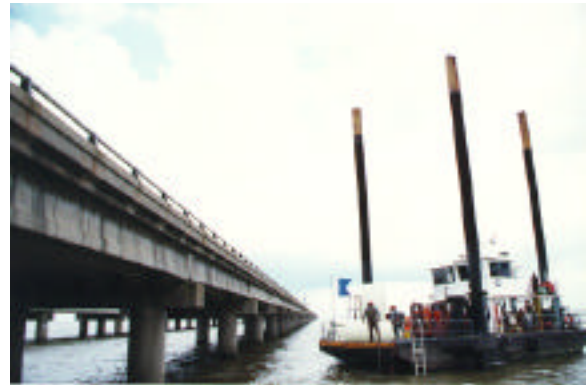
*Photo 2*

Jack-up vessels (Photo 2) and self-propelled barges were used for most of the work. This was due to both the strict navigation rules set forth in the contract, and also because of the volatile nature of the weather on Lake Pontchartrain. The Lake is a very large body of water with relatively shallow depths (avg. 16 ft.). Lake conditions become unworkable in a matter of minutes with any significant change in the wind.

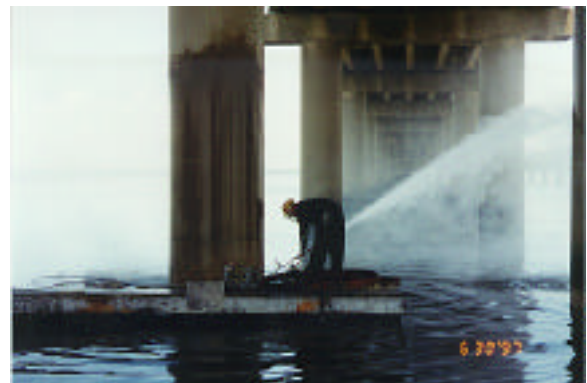
*Photo 3*

Surface preparation is critical on any encapsulation project. For this work, a 10,000 psi water blaster was used with the required operating pressures of between 7,000 psi and 8,000 psi (Photo 3). All marine growth was removed and proper concrete surface profile was established. Surface preparation was performed within 48 to 72 hours of grout placement.

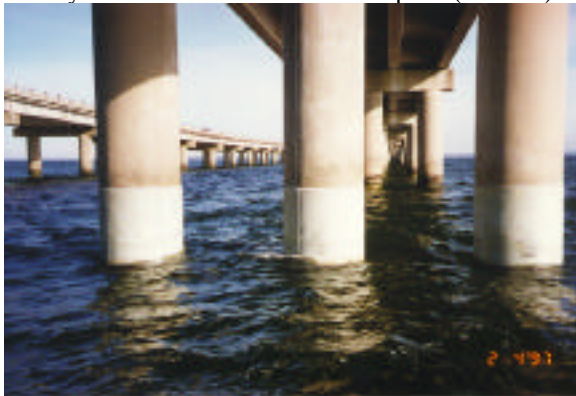
*Photo 4*

The encapsulations were topped-off with a fillet of marine grade, water insensitive, epoxy paste, forming a watershed at the top of each encapsulation. Once completed, the encapsulations were also aesthetically pleasing, as they only protrude a few inches from the pile surface and the color of the finished encapsulation closely matches that of the concrete piles (Photo 4).
